T Flat Panel Display Unit and Method of Repairing..

Atty Docket No. 16869P-031900

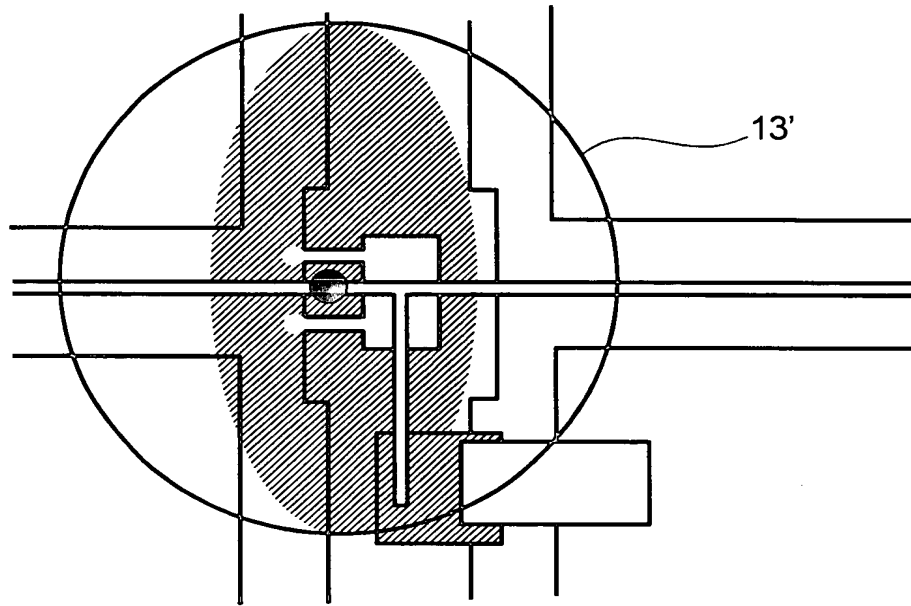
FIG.2

12 : Glass pipette

13 : Insulating film material

13' : Insulating film material coating range

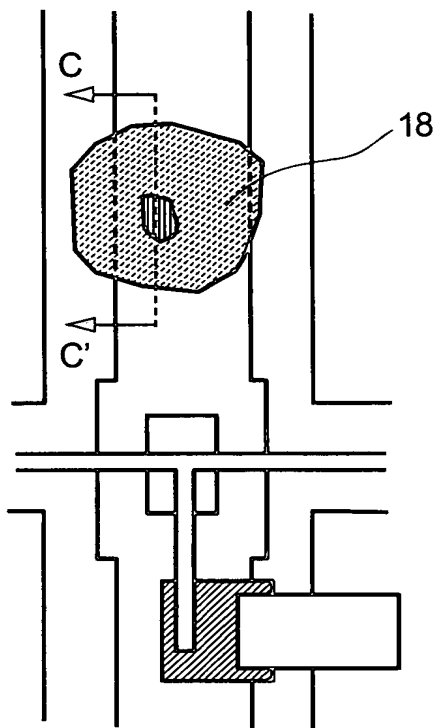
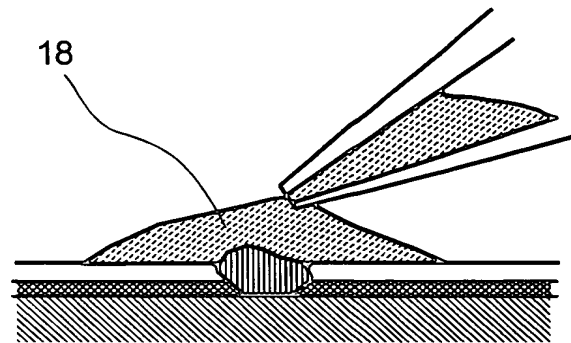
FIG.6

Cross section along C-C'

17 : Foreign object
18 : Insulating film material

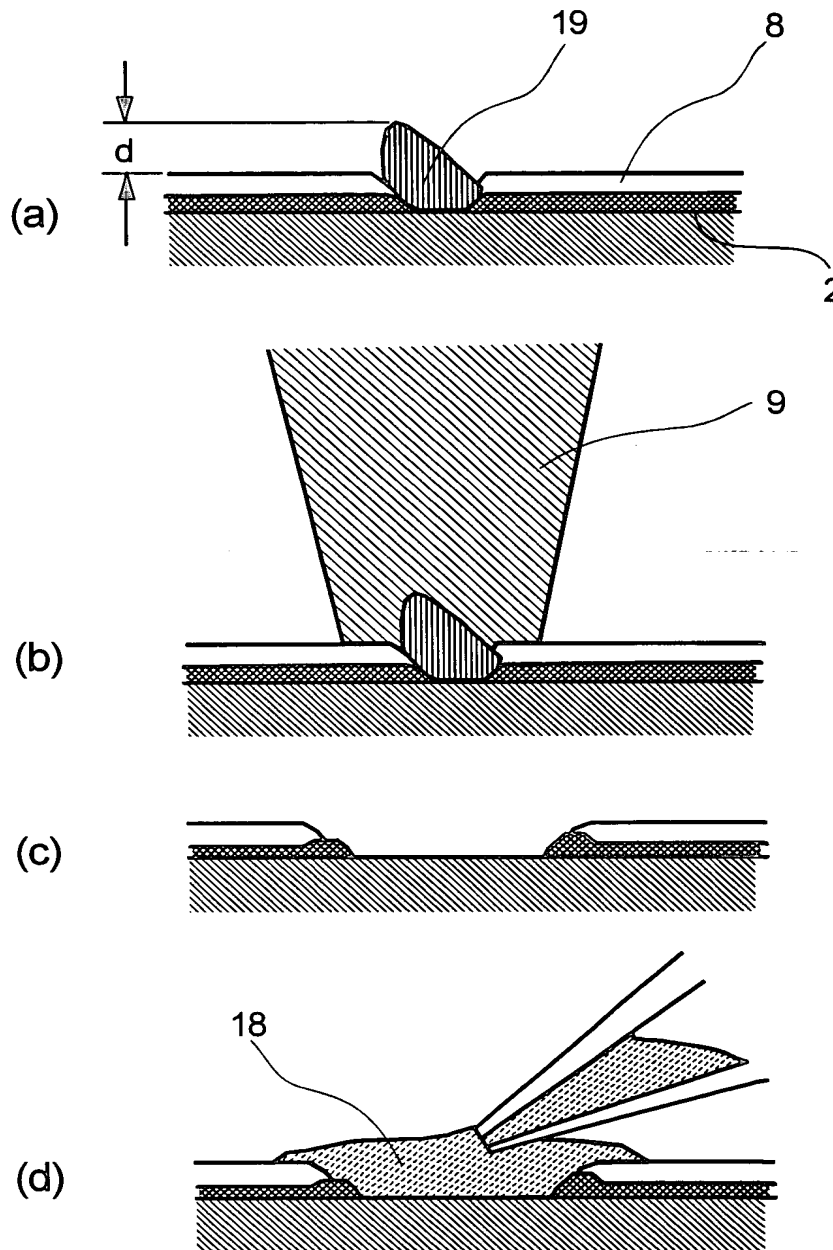
FIG.7

19 : Foreign object

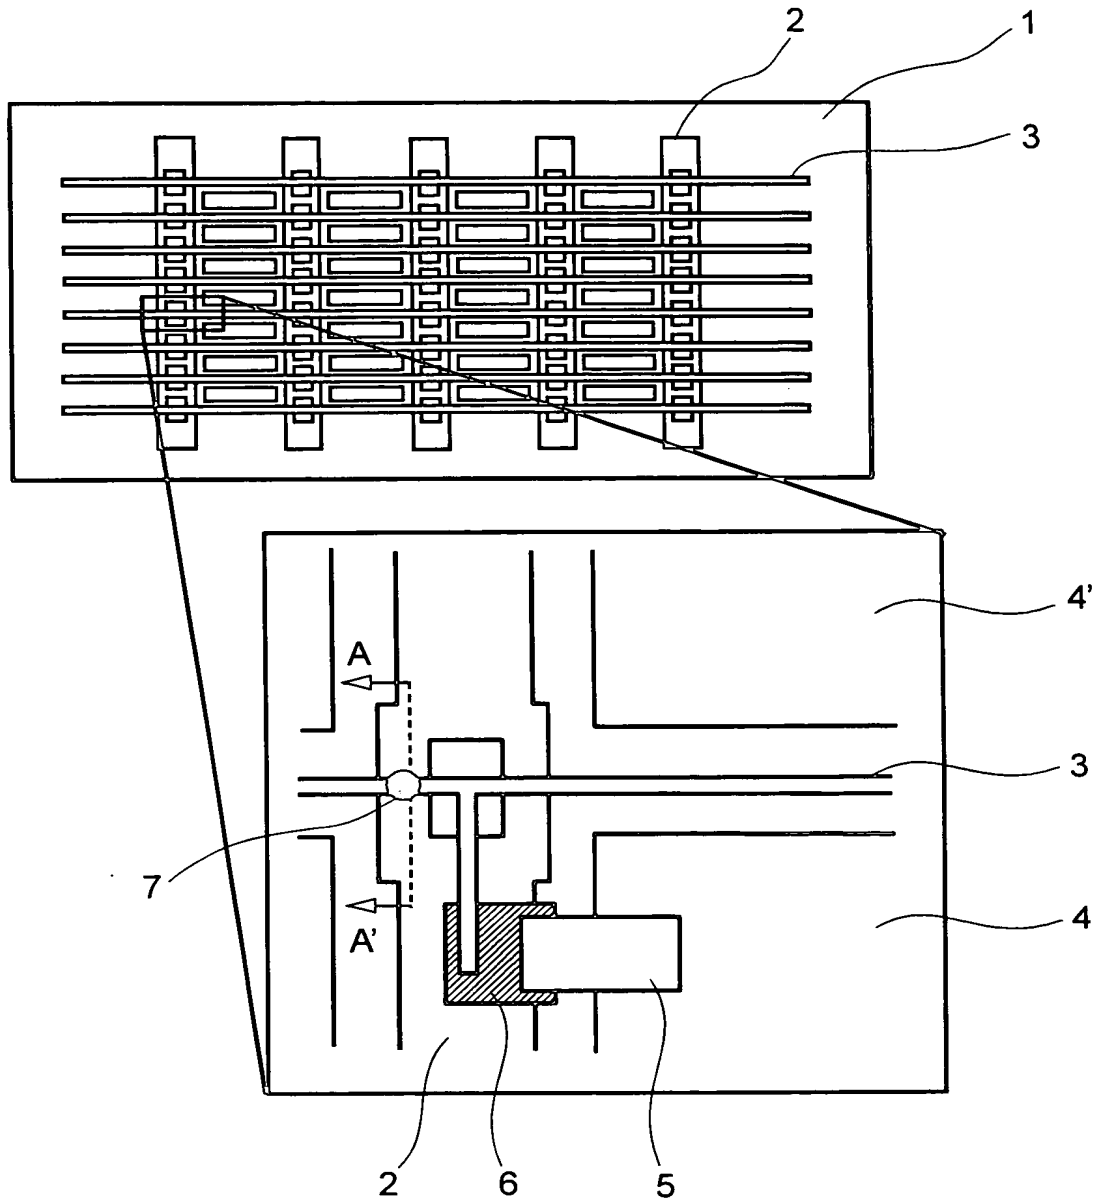
FIG. 8

- 1 : Glass substrate
- 2 : Scan line
- 3 : Signal line
- 4 : Pixel
- 6 : TFT structure
- 7 : Shorting defect portion

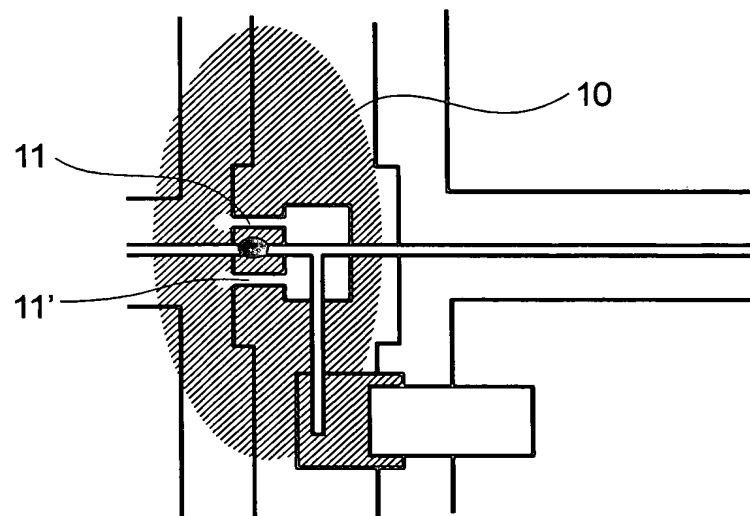
FIG.10

8 : Inter-layer insulating film

9 : Laser

10 : Dispersed metal

11, 11' : Portion severed by laser
